FINAL REPORT
SRB SEAWATER CORROSION PROJECT
July, 1991
(NAS8-38800)

Auburn University, Solid State Sciences Center,
Department of Physics

M. J. Bozack

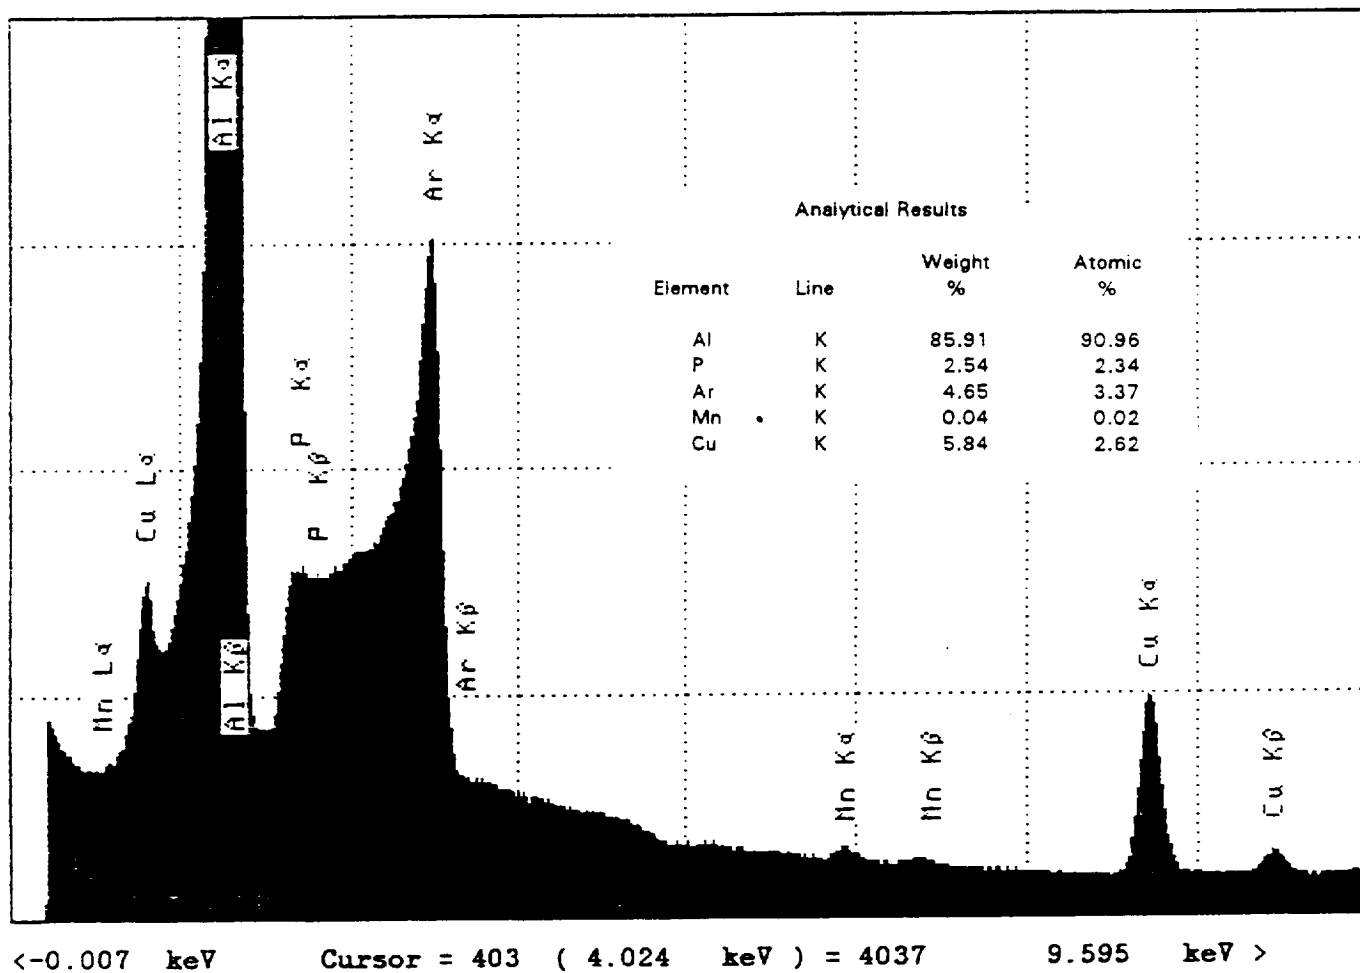
Fig. 3. EDX spectrum of as received 2219 aluminum used in SRB construction. The aluminum is an Al-Cu alloy composition with bulk contaminants of Ar, Mn, and P.

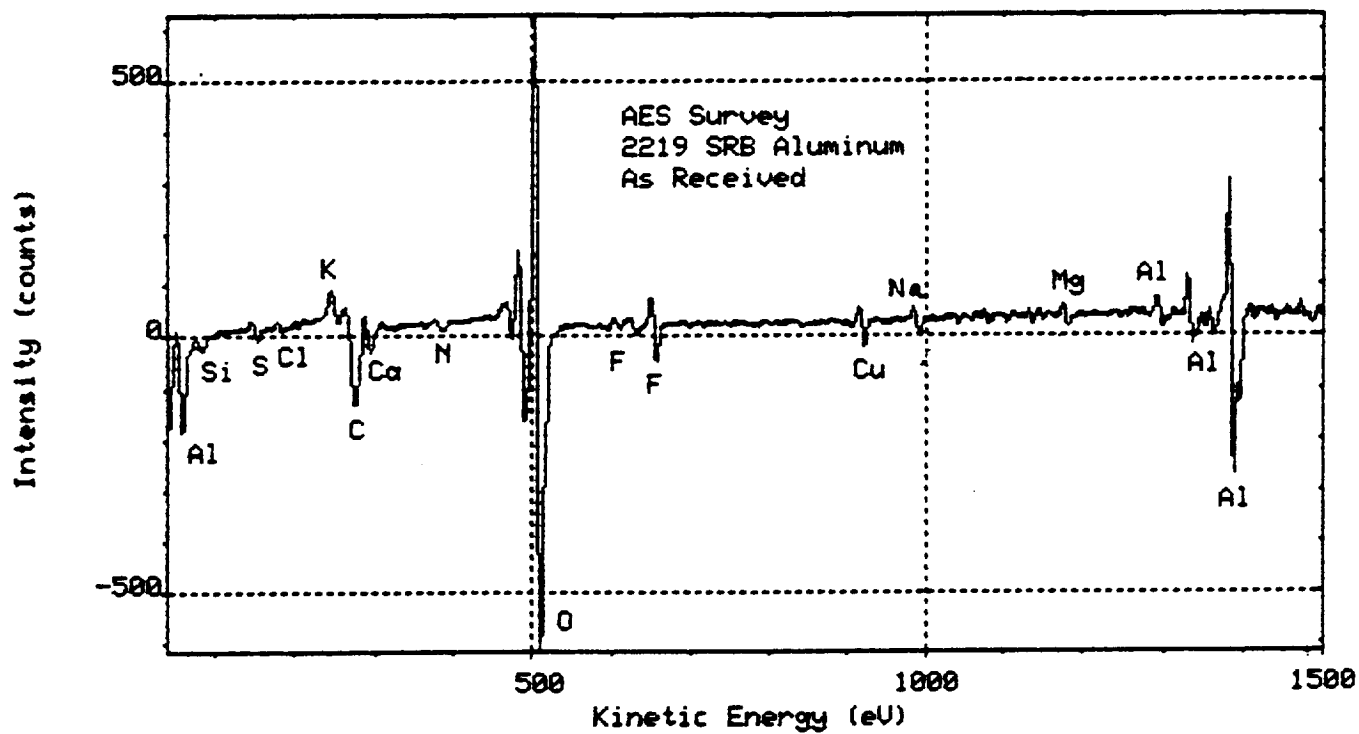
Fig. 4: Auger spectrum of as received 2219 aluminum used in SRB construction. The surface is oxidized with a number of contaminants present due to handling.

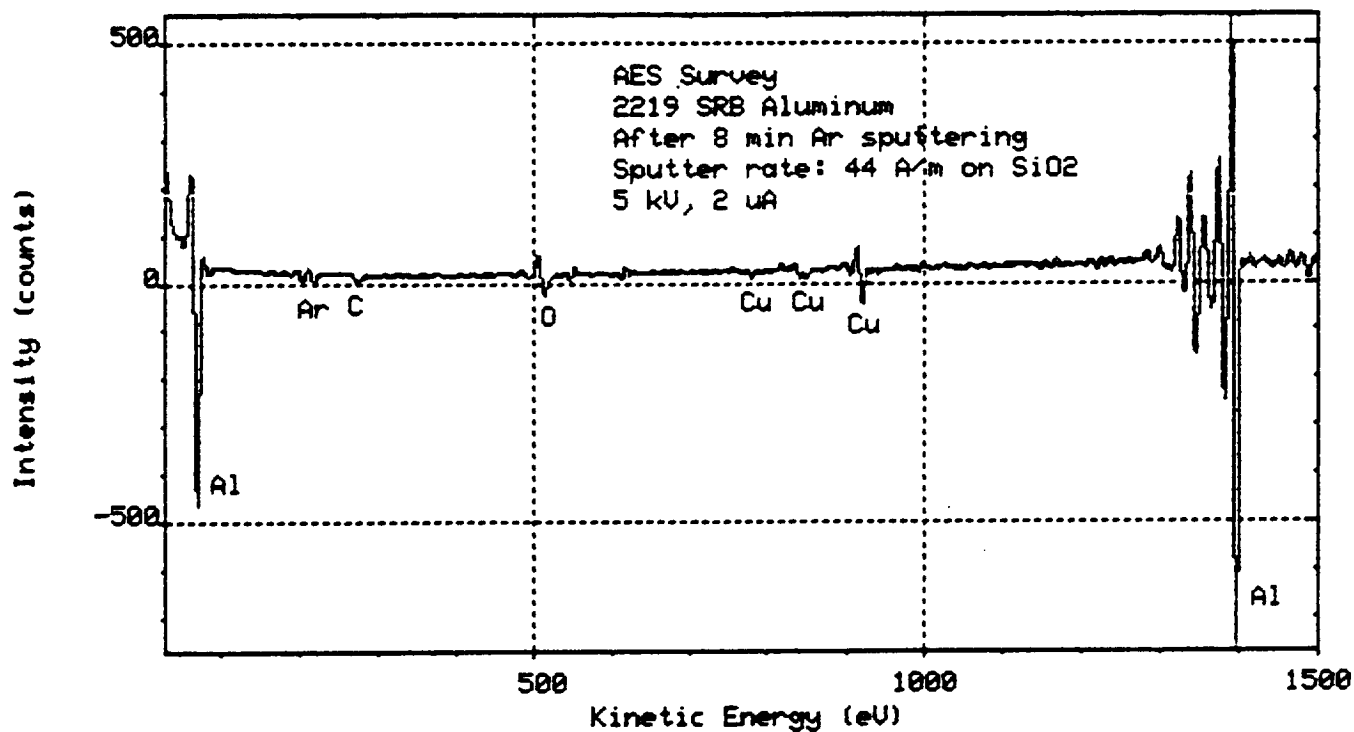
Figure 6 shows the Auger spectrum of the 2219 aluminum surface after 8 minutes of Ar sputter cleaning. The Ar was supplied by an rastered ion gun operating at 3 kV energy. The sputter rate was 44 Å/min as measured on a standard of SiO₂. Assuming the sputter rates of SiO₂ and Al are equal, roughly 350 Å of the surface have been removed. The oxide layer and surface contaminants have been sputtered away and only signals from Al, O, C, and Ar are found. The Ar present is due to implantation from the ion gun, while the small amounts of C and O remaining appear to be incorporated into the aluminum (EDX cannot detect these elements). The Cu is part of the bulk alloy composition of 2219 aluminum, seen in EDX analysis. The Al(KLL) lineshape is characteristic of elemental aluminum (cf. Fig. 5). Careful sputtering studies showed the native oxide layer to be roughly 150 Å thick. After extensive sputtering (20-30 min), the Auger spectrum looked identical to that in Fig. 6, verifying the EDX results for the bulk composition. No other elements were observed within the detectability limit for Auger spectroscopy (0.1 % of a monolayer).

Fig. 6. Auger spectrum of 2219 aluminum after Ar sputter cleaning. The bulk alloy composition is reached after about 150 Å of sputtering.

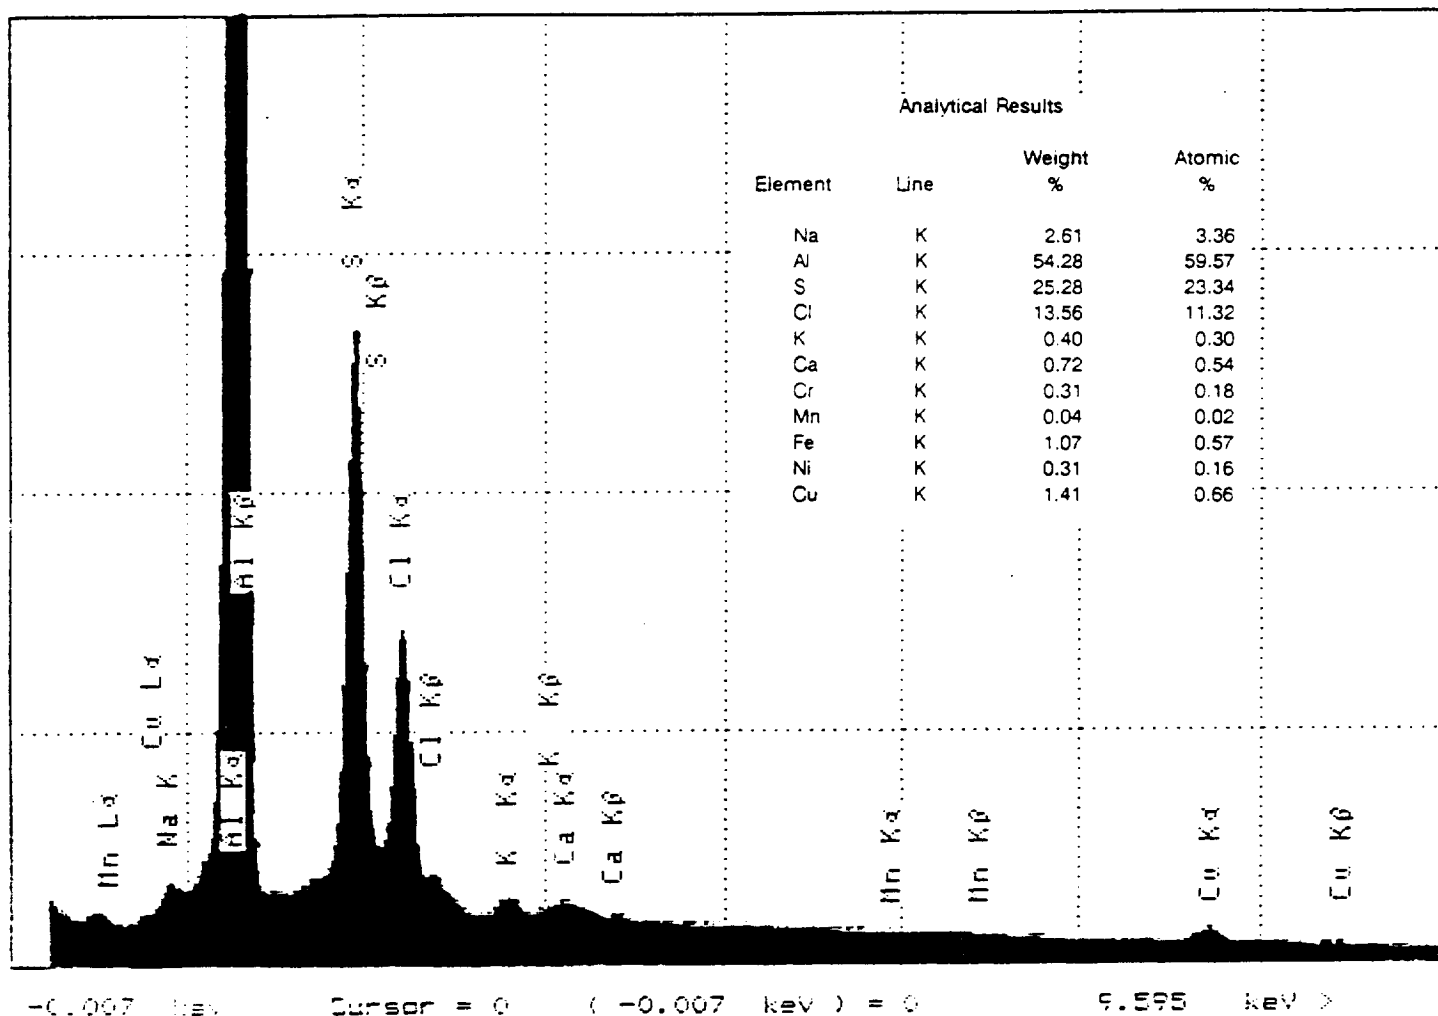
EDX analysis of one of the crystalline mounds (position 1 in Fig. 8(b)) is shown in Figure 9. The mound is mostly Al, S, Na, and Cl with small ($< 2\%$) percentages of K, Ca, Cr, Mn, Fe, Ni, and Cu. It is questionable how much of the Al signal originates from the mound and how much originates from the Al substrate. This is because the thickness of the material is unknown. The incident electron beam penetrates roughly 1 micron of material per every 10 kV of accelerating voltage, and since the analysis was carried out at 25 kV, this means that the majority of X-rays originate from material located a couple of microns under the surface. Further, it is possible to have substantial electron scattering when performing EDX analysis on rough, irregular features. The scattered electrons can excite X-rays in nearby (substrate) material and give the impression that more aluminum is in the analysis feature than is real. Auger analytical results discussed below resolves this situation.

Fig. 9. EDX spectrum atop a localized mound of second phase material (position 1 in Fig. 8(b)). The major elemental constituents are Al, S, Na, and Cl. The EDX technique with our current X-ray window cannot detect elements with atomic number $Z < 11$ (Na).

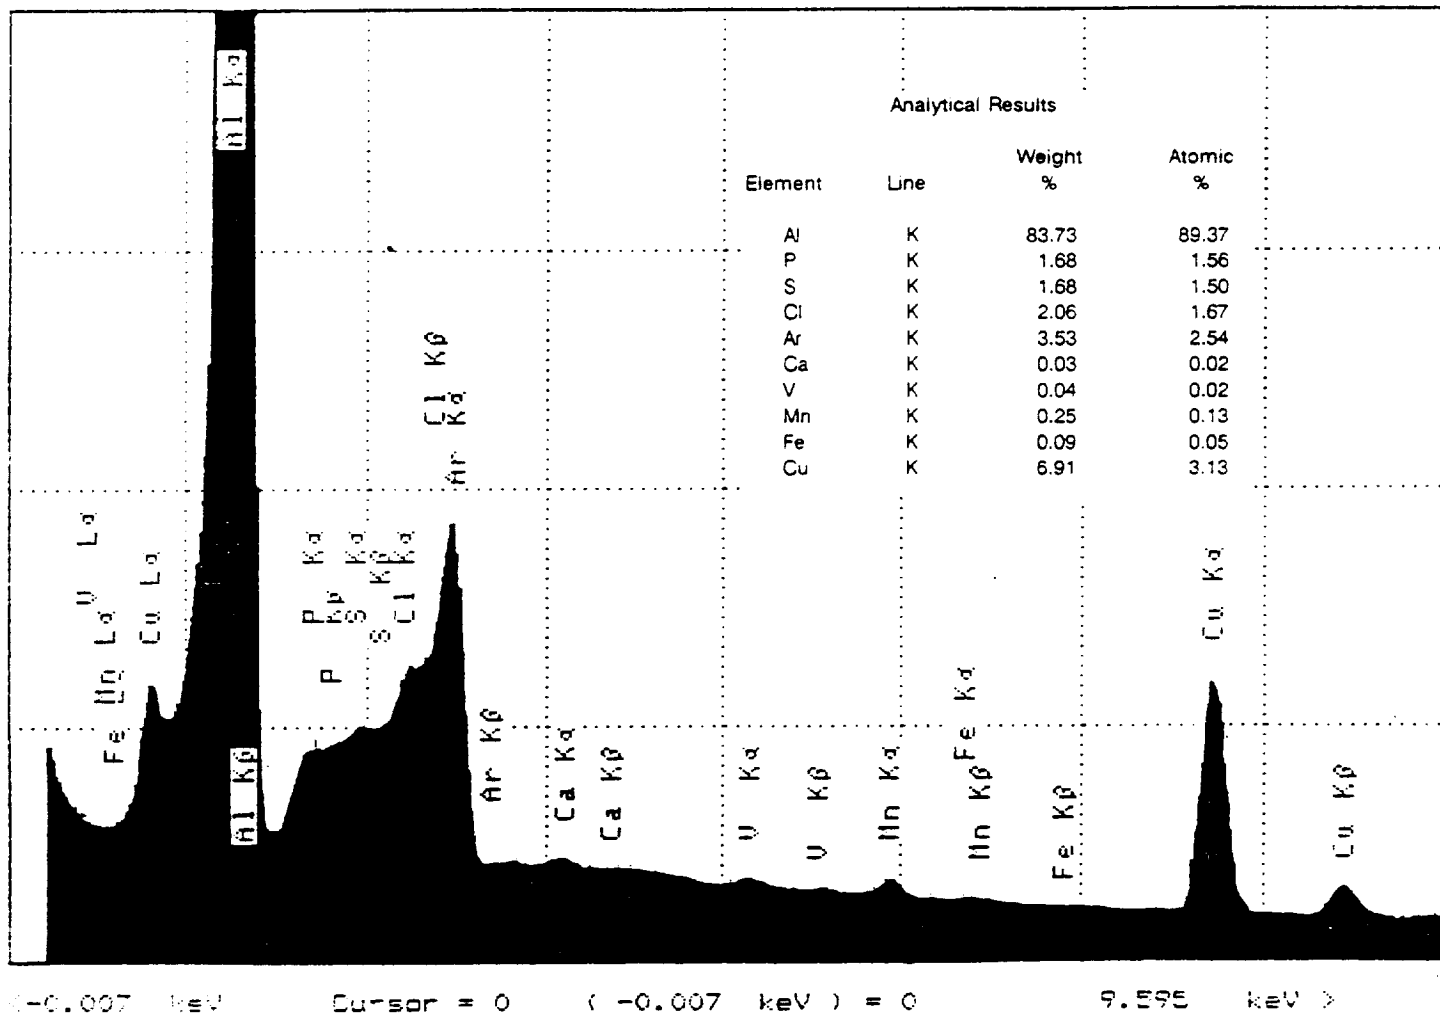
EDX analysis of the exposed aluminum surface away from the corrosion mounds is shown in Figure 10. The composition is nearly identical to the unexposed bulk alloy composition. It is likely that reaction products are present, but reside in a thin surface layer that are missed by the deep penetration of the incident electron beam. This is indeed the case, shown by Auger analysis.

Fig. 10. EDX spectrum of the 2219 aluminum surface away from a corrosion mound (position 2 in Fig. 8(b)). The composition reflects the bulk alloy composition with the addition of small quantities of S, Cl, Ca, V, and Fe.

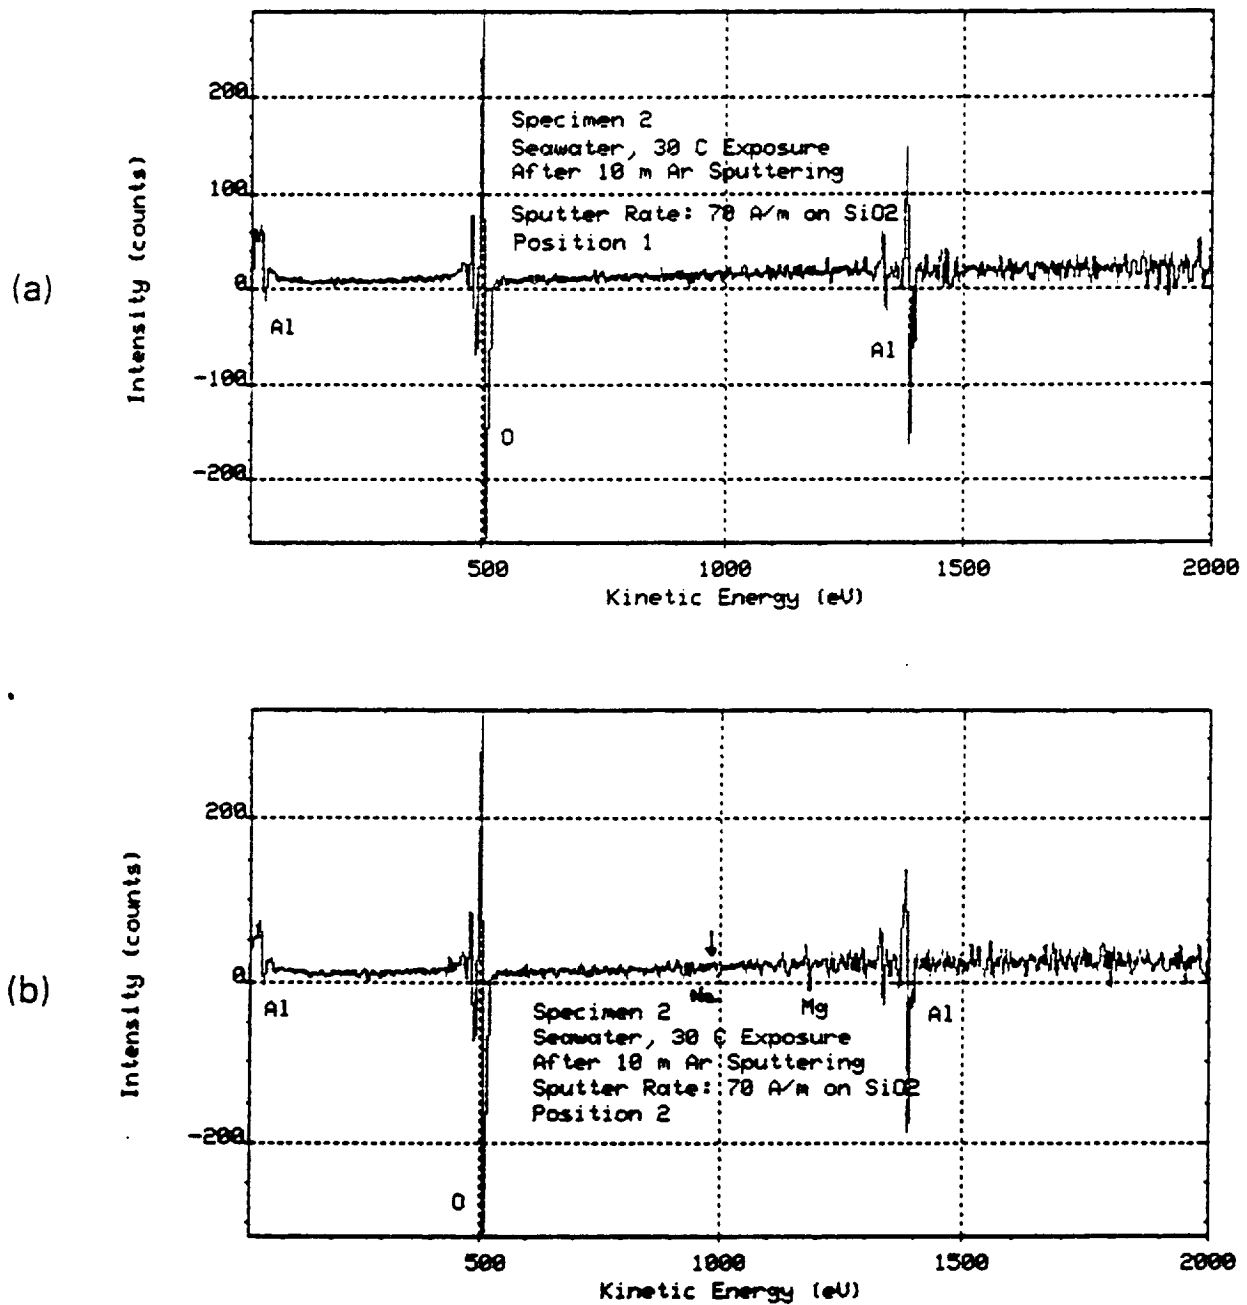
That much of the Al signal seen in EDX analysis originates from the corrosion mounds rather than the 2219 substrate itself was found during Auger analysis of the corrosion surface. In fact, Auger analysis makes it clear that Al is present in the mounds in the form of aluminum oxide (Al_2O_3). Auger analysis atop the localized mound (position 1 in Fig. 8) is shown in Figure 11(a). The Auger signature is clearly that of Al_2O_3 , shown both by the energies and shapes of the Al Auger peaks. Auger analysis off to the side of the mound (position 2 in Fig. 8) is nearly identical to the Auger spectrum on the mound, with the addition of Mg. We attempted to determine how thick the mound of Al_2O_3 was by sputter etching through it. Based upon a sputter rate of $70 \text{ \AA}/\text{m}$ on SiO_2 (a common calibration material), it took roughly 4.5 hours to drill through the mound, corresponding to a thickness of ~ 1.9 microns. Since the spectroscopic information from EDX originates from roughly the top 2-3 microns of the surface, most of the elements found in earlier EDX spectra on localized mounds originate from the mounds themselves rather than from the 2219 substrate.

Fig. 11. Auger spectra (a) atop and (b) beside the localized mound in Figure 8 (see positions 1 and 2 in Fig. 8). The signatures are those of Al_2O_3 and MgO . The mounds appear to be primarily Al_2O_3 while the adjacent areas are both Al_2O_3 and MgO . The specimens were Ar sputtered for 10 minutes beforehand to remove traces of adsorbed residual atmospheric gases.

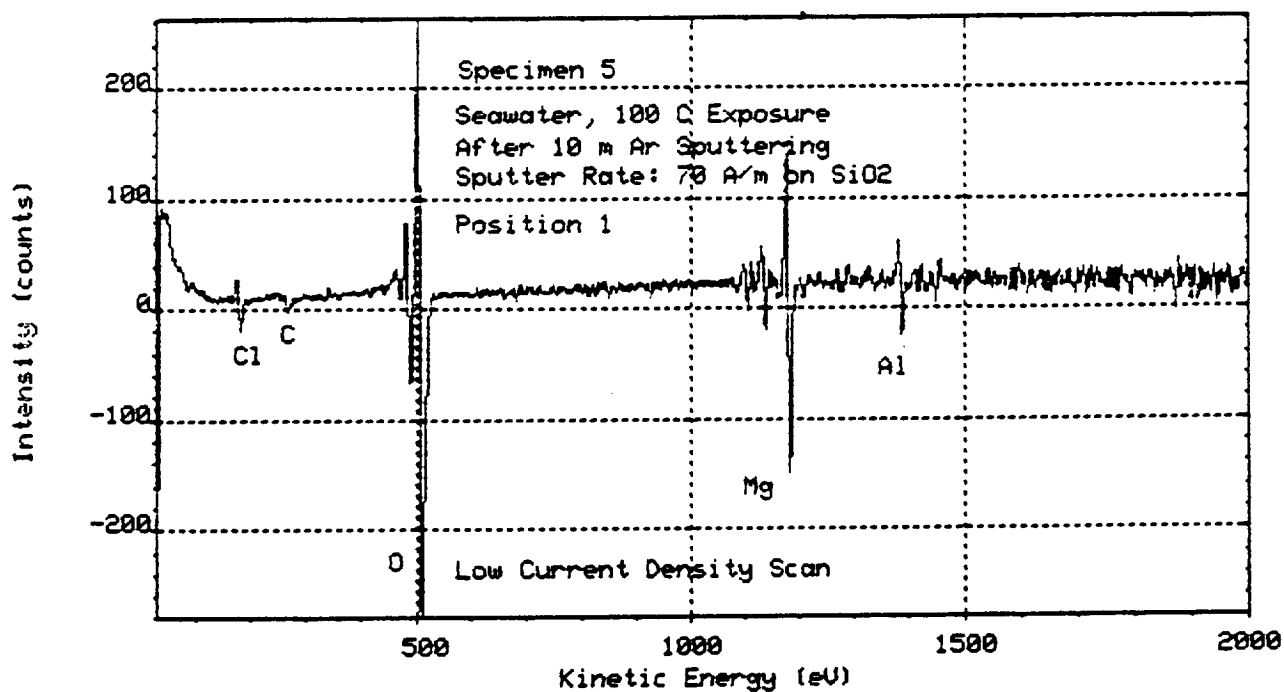
ESD effects on seawater exposed 2219 surfaces is observed in Figure 12. This figure shows an Auger spectrum from the $T = 100 \text{ C}$ surface (discussed ahead; cited here for illustrative purposes only) which EDX analysis showed to

Fig. 12. A low current density Auger spectrum atop the $T = 100\text{ C}$ reaction surface (cf. Fig. 24 for a high current scan), illustrating the effects of electron stimulated desorption on Auger spectra. Lower current densities result in reduced Cl desorption and a larger Cl peak.

contain substantial Cl, but at low voltage and current density which minimizes the effects of ESD. The Cl signal is clearly evident. Further evidence of ESD phenomenon involves the diminution of the Cl Auger feature with scan time. The magnitude of the Cl Auger peak diminishes significantly with scan time. By the time the S/N is sufficient in most spectra, the Cl has all desorbed. The moral is clear: both EDX and AES are necessary for complete analysis of surfaces exposed to seawater (chlorinated) solutions. Since most of the EDX signal originates from beneath the surface, the effects of ESD in EDX spectroscopy are minimal. The limitation of EDX, however, is that it cannot detect elements with $Z < 11$ (Na) with our current X-ray window.

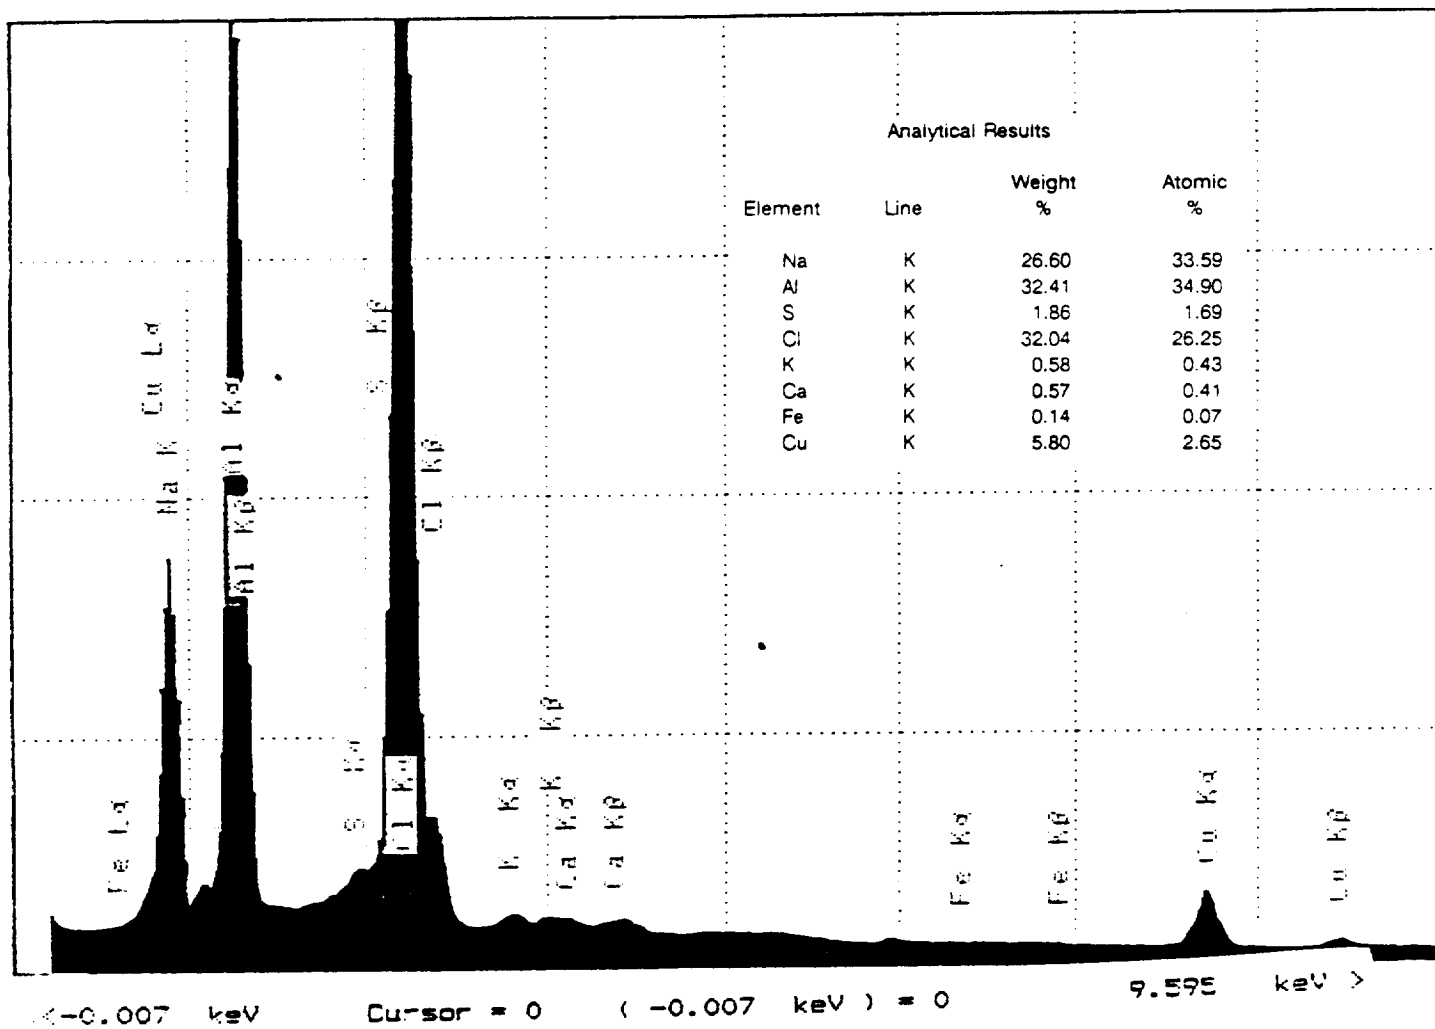
High magnification SEM views after seawater exposure at $T = 60\text{ C}$ are shown in Figures 14 and 16. Figure 14 shows two areas of the surface where growth of cubic crystalline material is extensive. An EDX spectrum atop one of the cubic structures (position 1 in Fig. 14(a)) is displayed in Figure 15. The crystal is composed primarily of Al, Na, and Cl. It is clear that the cubic crystals are NaCl and it is likely that the corrosion of the Al is catalyzed by the salt and sulphate ions in seawater, similar to rust developing on a car in wintertime when exposed to salt on an icy roadway.

Fig. 15. EDX spectrum atop one of the cubic structures (position 1 in Fig. 14). The major elemental constituents are Al, Na, and Cl.

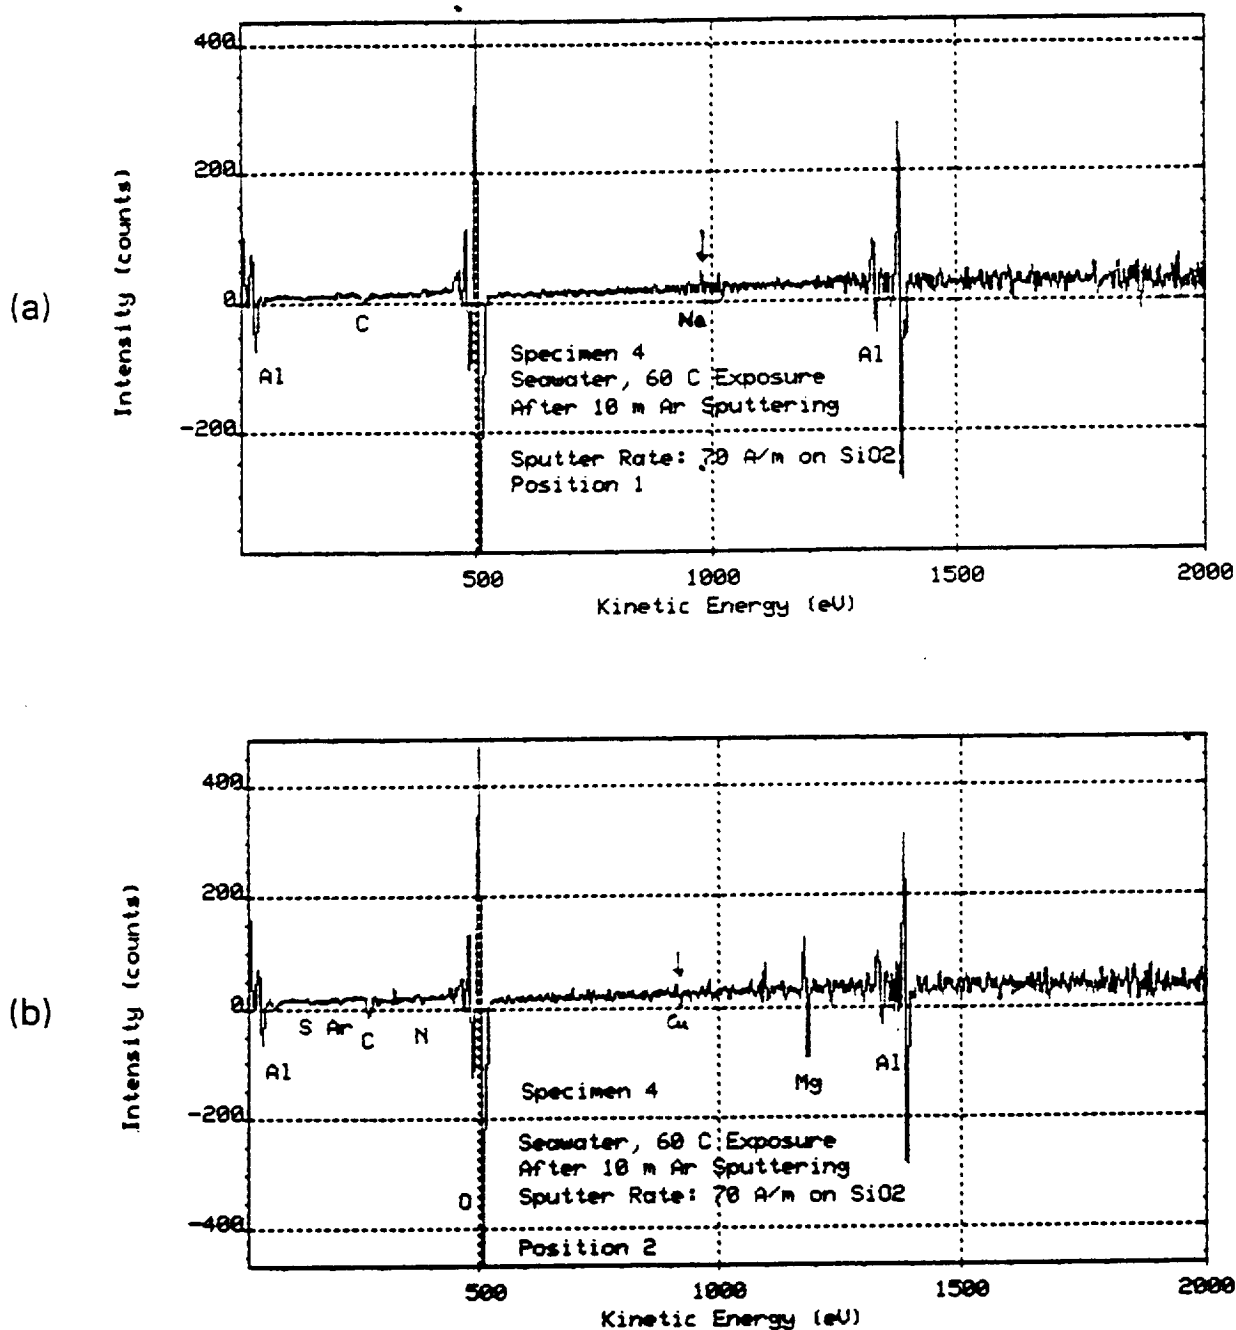
Fig. 17. Auger spectra (a) atop and (b) beside one of the localized mounds in Figure 16 (see positions 1 and 2 in Fig. 16). The mounds appear to be primarily Al_2O_3 while the adjacent areas are both Al_2O_3 and MgO . Exposure at higher temperature favors formation of MgO . The specimens were Ar sputtered for 10 minutes beforehand to remove traces of adsorbed residual atmospheric gases.

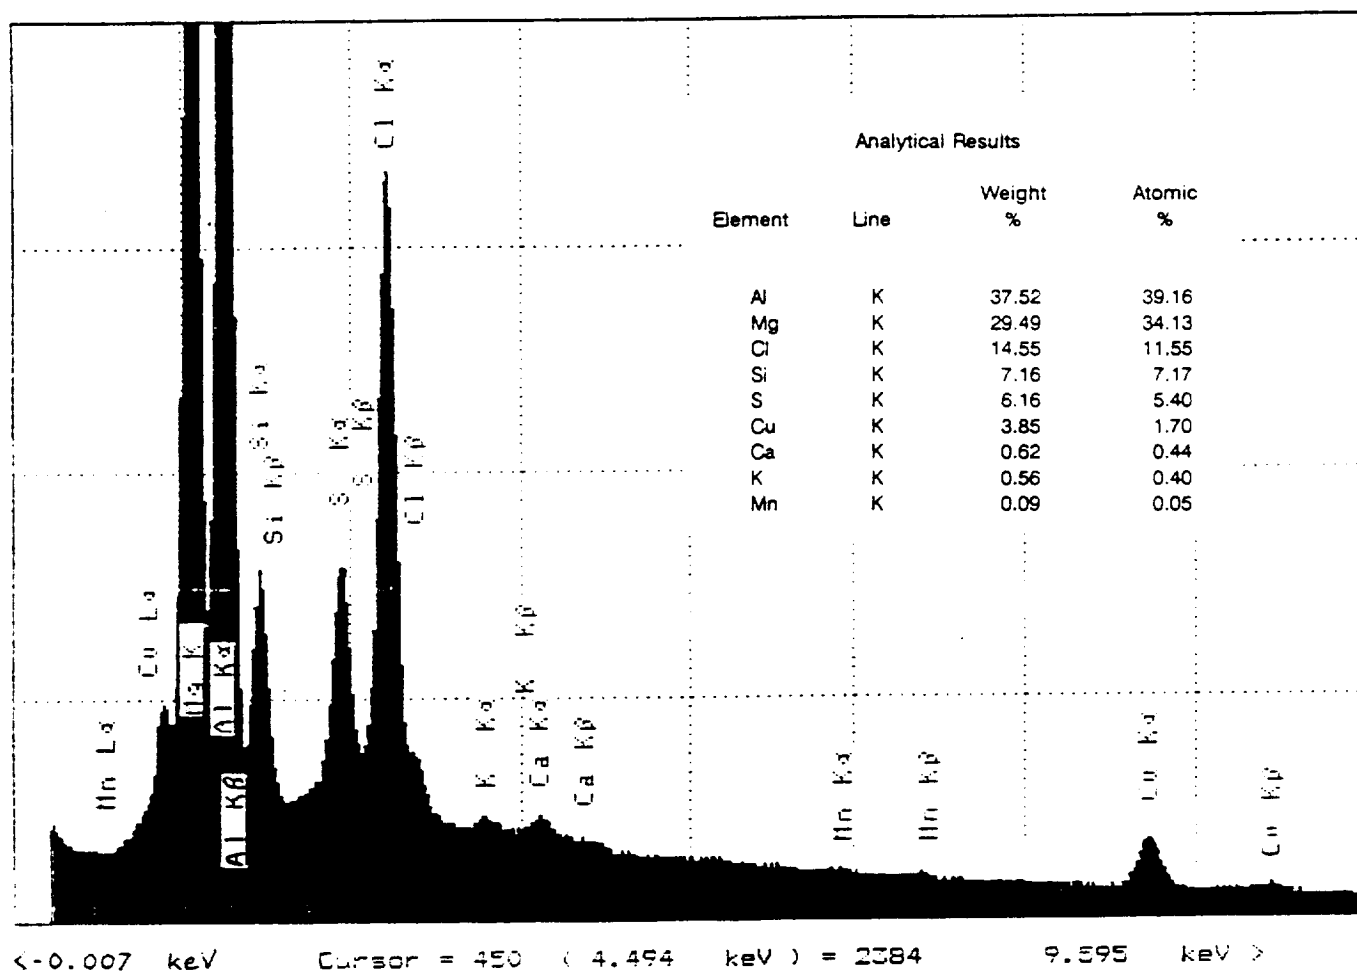
Fig. 22. EDX spectrum atop a large crystal of second phase material (position 1 in Fig. 21(a)). The major elemental constituents are Al, Mg, and Cl. No Na is observed, in contrast to seawater exposures at $T = 30$ C and $T = 60$ C.

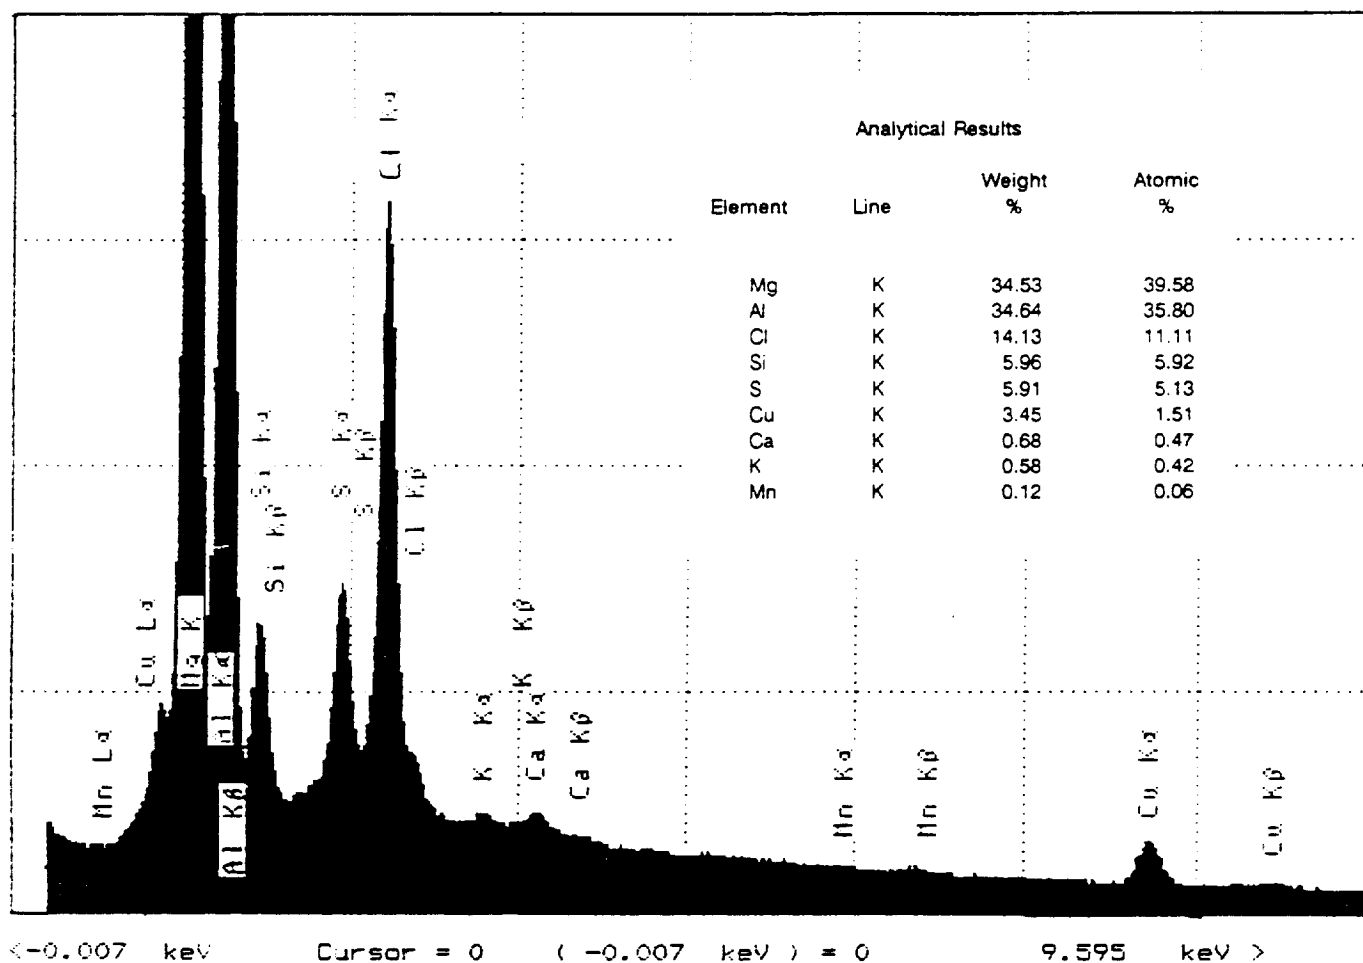
Fig. 23. EDX spectrum atop the corrosion products at position 2 in Fig. 21(a). The major elemental constituents are Mg, Al, and Cl. No Na is observed, in contrast to seawater exposures at $T = 30\text{ C}$ and $T = 60\text{ C}$.

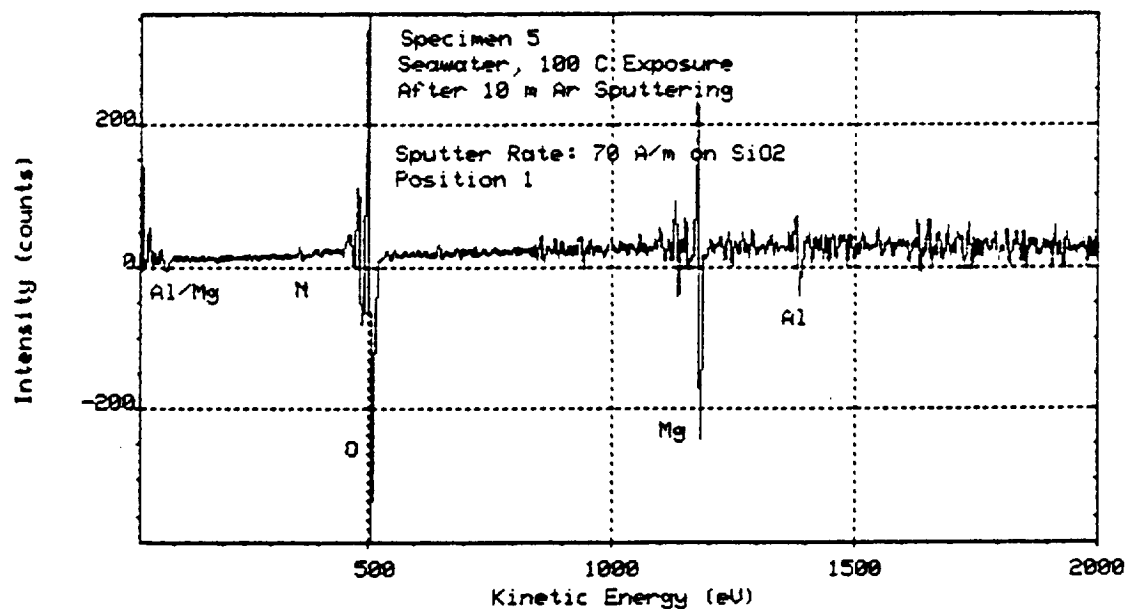
Fig. 24. Auger spectrum atop the $T = 100$ C reaction surface. Exposure at higher temperature favors formation of MgO . The specimens were Ar sputtered for 10 minutes beforehand to remove traces of adsorbed residual atmospheric gases.

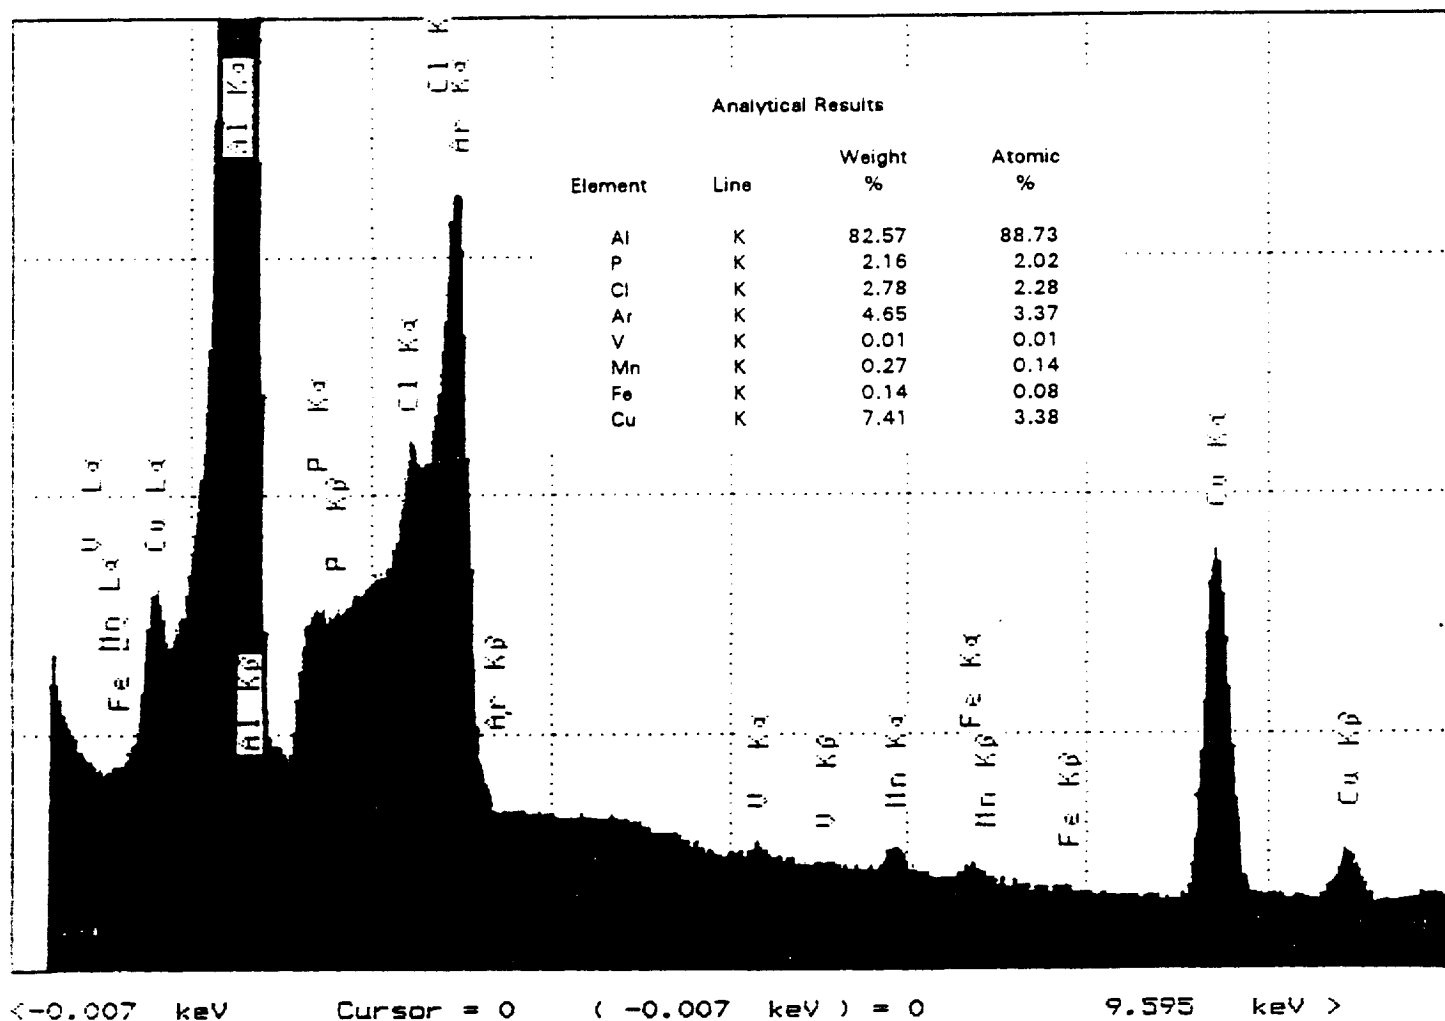
Fig. 27. EDX spectrum inside one of the corrosion features created by 3.5 % salt solution exposure at $T = 30\text{ }^{\circ}\text{C}$ (position 1 in Fig. 26(b)). The spectrum is similar to the 2219 alloy itself, with the addition of a small amount of Cl (cf. Fig. 3).

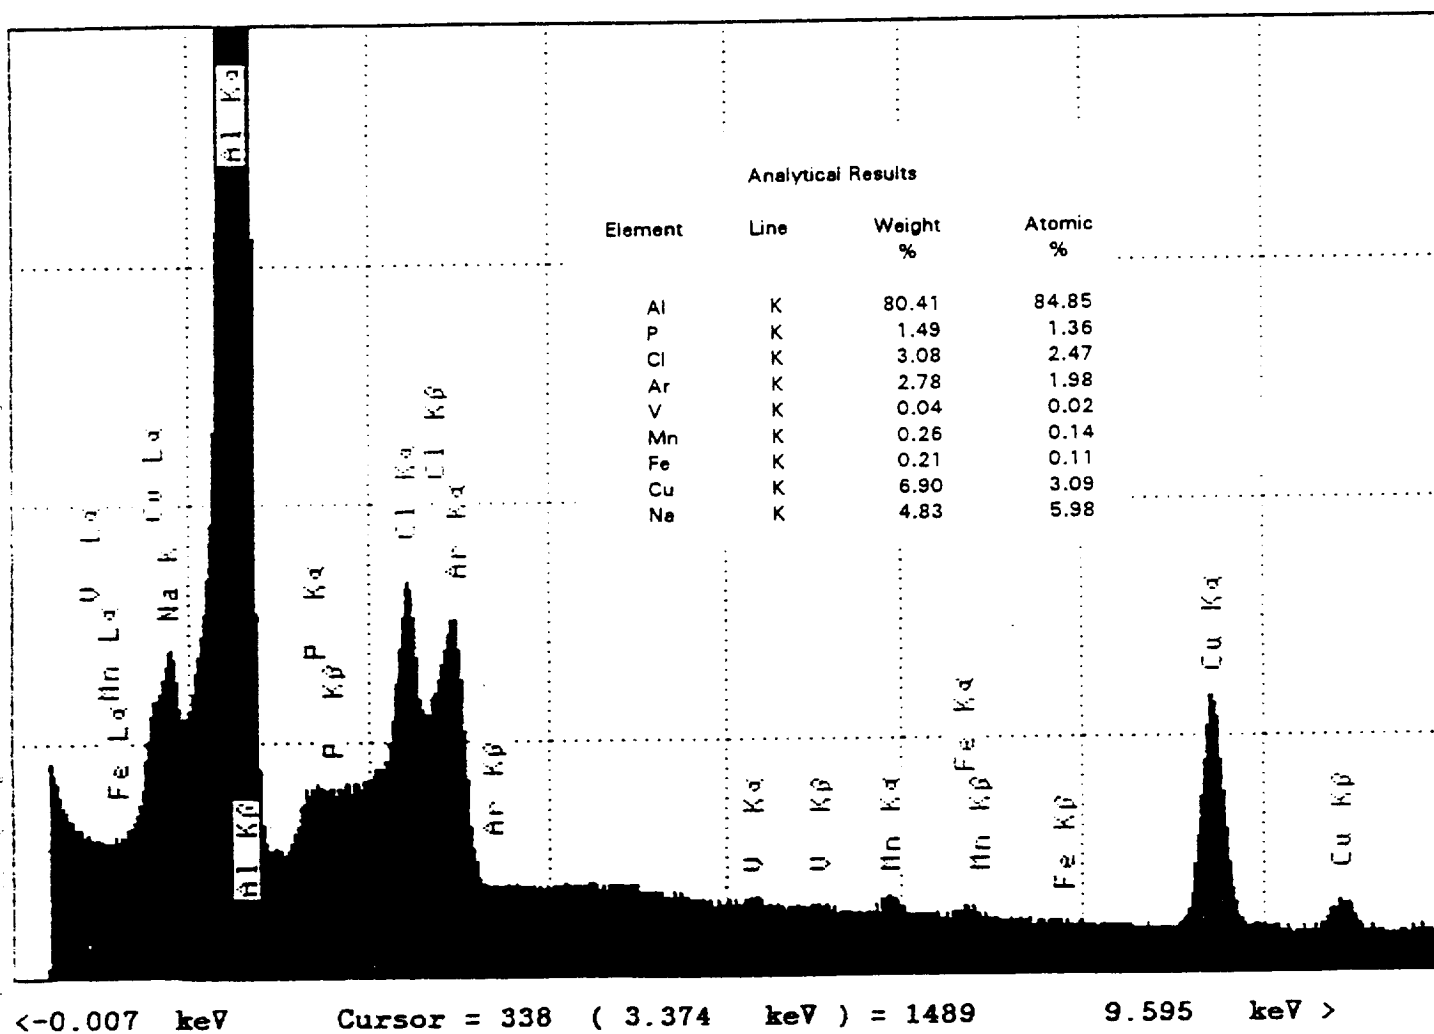
Fig. 28. EDX spectrum alongside one of the corrosion features created by salt solution exposure at $T = 30\text{ C}$ (position 2 in Fig. 26(b)). The surface next to the feature contains a larger signal of Cl and the presence of Na.

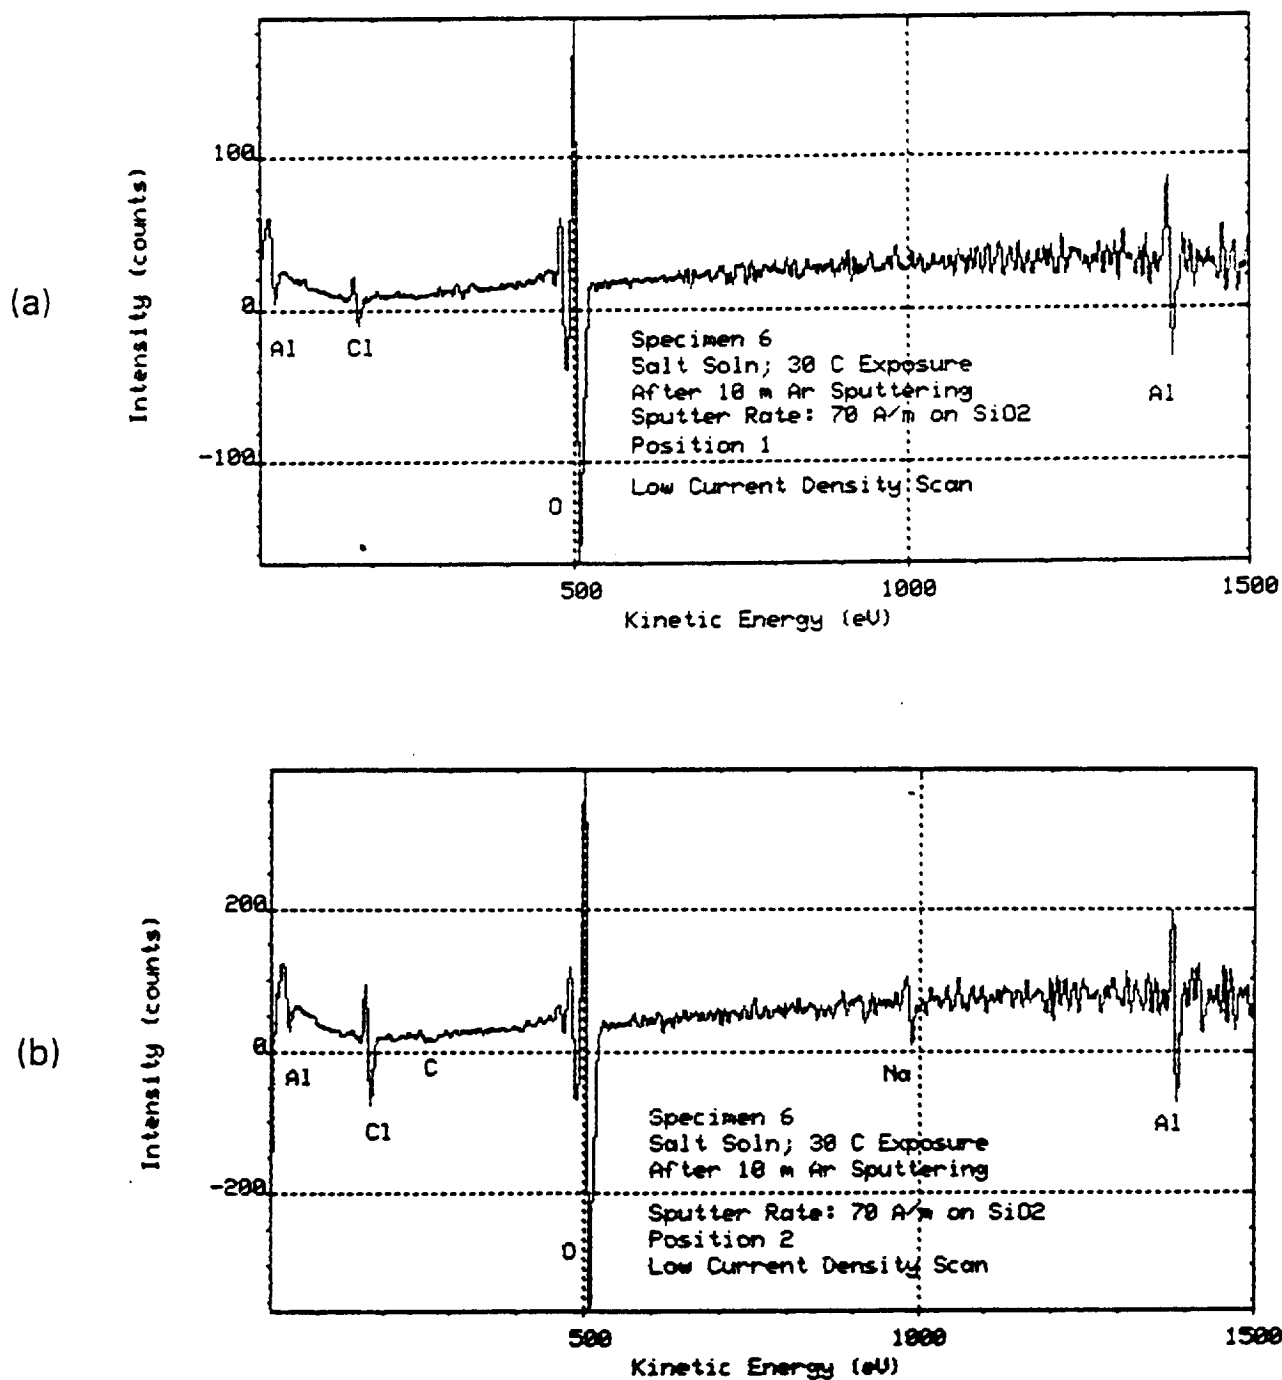
Auger analysis atop one of the localized mounds (position 1 in Fig. 25) is shown in Figure 29(a). The spectrum demonstrates that the major corrosion product is Al_2O_3 , shown by the energies and shapes of the Al Auger peak. Auger analysis off to the side of the mound (position 2 in Fig. 26) is nearly identical to the Auger spectrum on the mound, with the addition of more Na and Cl. The analyses were performed at low incident beam current to minimize the effects of electron stimulated desorption (ESD), discussed above. Accounting for this effect in Auger spectroscopy, and comparing spectra taken by EDX, shows that the predominant reaction mechanism at $T = 30\text{ C}$ is growth of Al_2O_3 and NaCl.

Fig. 29. Auger spectra (a) atop and (b) beside the localized mound in Figure 25 (see positions 1 and 2 in Fig. 25(b)). The Auger signature is that of Al_2O_3 , while EDX additionally showed NaCl. The specimen was Ar sputtered for 10 minutes beforehand to remove traces of adsorbed residual atmospheric gases.
